**V.V. Sukhorukov\***, **V.S. Kotelnikov\*\***, **V.G. Zhukov\*\*** & **A.A. Khudoshin\*\*\*** ODN 0750  
\*Intron Plus Ltd., \*\*Gosgortekhnadzor, \*\*\*Tekhkranenergo Ltd.

## **Importance of rope NDT for safe lifting of loading cranes**

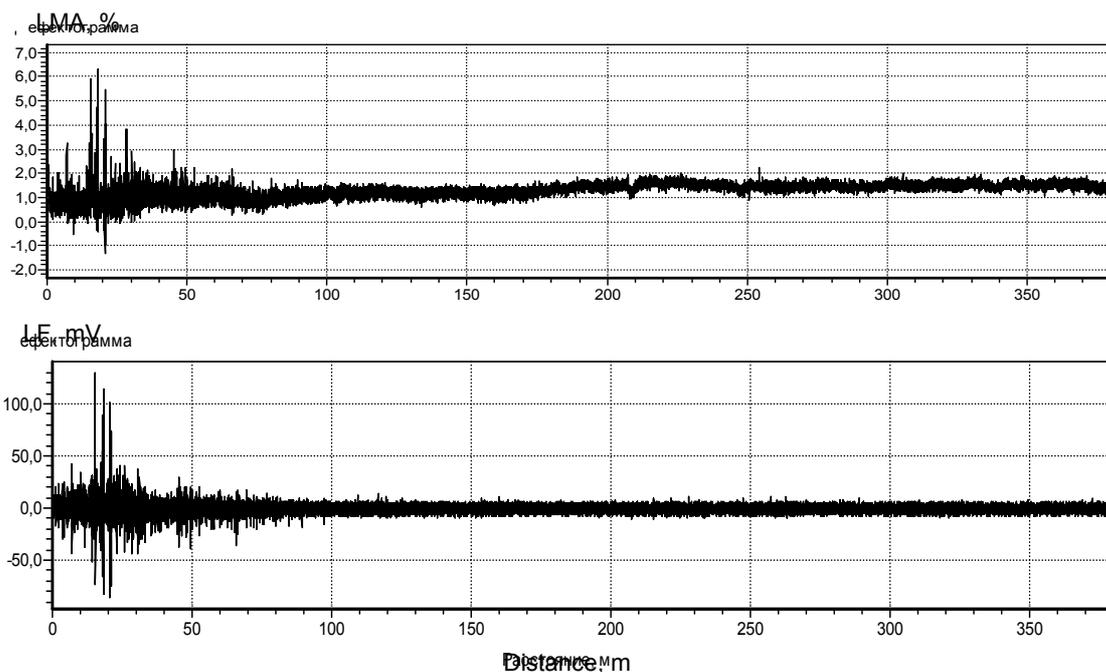
**Figure 1:** Data charts of the crane POTAIN MD-185A loading rope (rope A).

Figure 1 shows traces of the rope in two channels: LMA and LF. The most worn section locates at distance (0-60) m from the place of the rope fastening. There is more than 6% LMA and many wire breaks.

The tower crane POTAIN MD-185A failed in Khimky, a town in the region of Moscow in September 2001: a worker was killed. The reason for the accident was that the hoisting rope broke. The rope was 14 mm diameter, two-layer type; with construction 11x7(6/1)+6x7(6/1) with a metal core 1x7(6/1). Part of the rope, 380 m long was tested by the magnetic flaw detector INTROS after the break.

Visual checking of the rope sections 364-380 m upon dismantling of the sections confirms the magnetic testing data (Figure 1): there are no LF and considerable LMA. Certified data on the breaking strength of two rope fragments taken from the section 364-380 m differed from the data of tensile test machine by no more than 3% and 5% respectively.

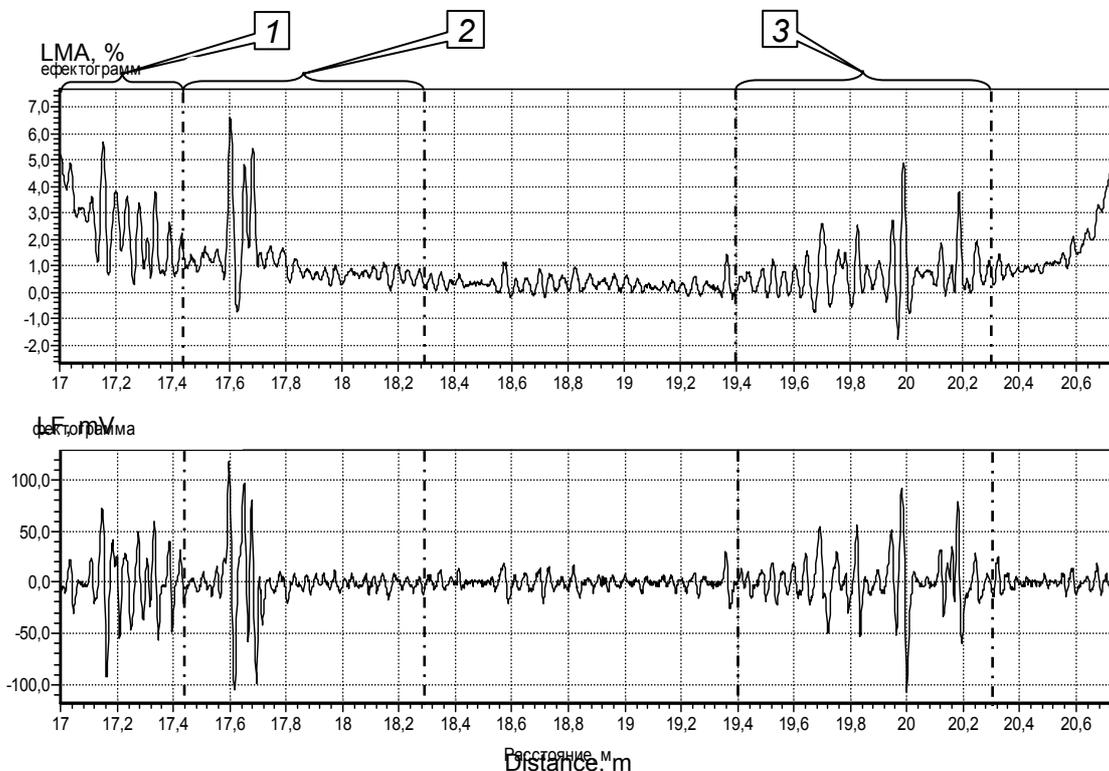
The traces of the rope section at distance 17-21 m are shown in Figure 2. The highest density of wire breaks is at 17.0-17.7 m and at 19.4-20.3 m. More than 35 wire breaks were identified the section 1 over a length  $30d = 0.42$  m at the location 17.0-17.7 m from analysis of the LF trace. This is significantly more than the discard criterion (8 breaks) in the length  $30d$ . That means the rope must be rejected.

**Figure 2:** LF and LMA traces of the rope A, section 17-21 m.

The section 1 of the rope was unwound. The results were: 25 breaks in the outer layer, 88 – in the inner, 13 – in the core, total – 126 breaks. The significant difference in quantity of rope breaks detected by the instrument and visually by unwinding could be explained due to the following reasons. Firstly, part of inner layer wires breaks while the rope is dismantled, because the wires will have accumulated fatigue during rope use. Almost all wires of the inner layer in this rope section will have lost their bending resistance and practically crumbled while unwinding. Secondly, the rope section investigated (Figure 3) contains many breaks located very close each other and break signals are imposed each upon other. That is why the signal identification is difficult.

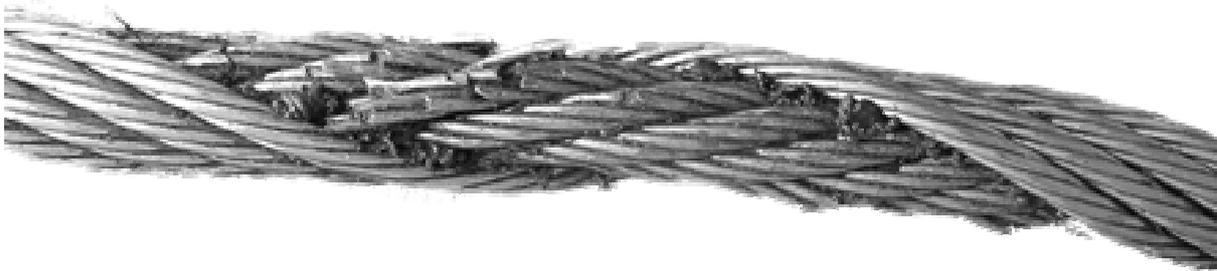
**Figure 3:** Section 1 of the rope A with outer layer strands partly removed.

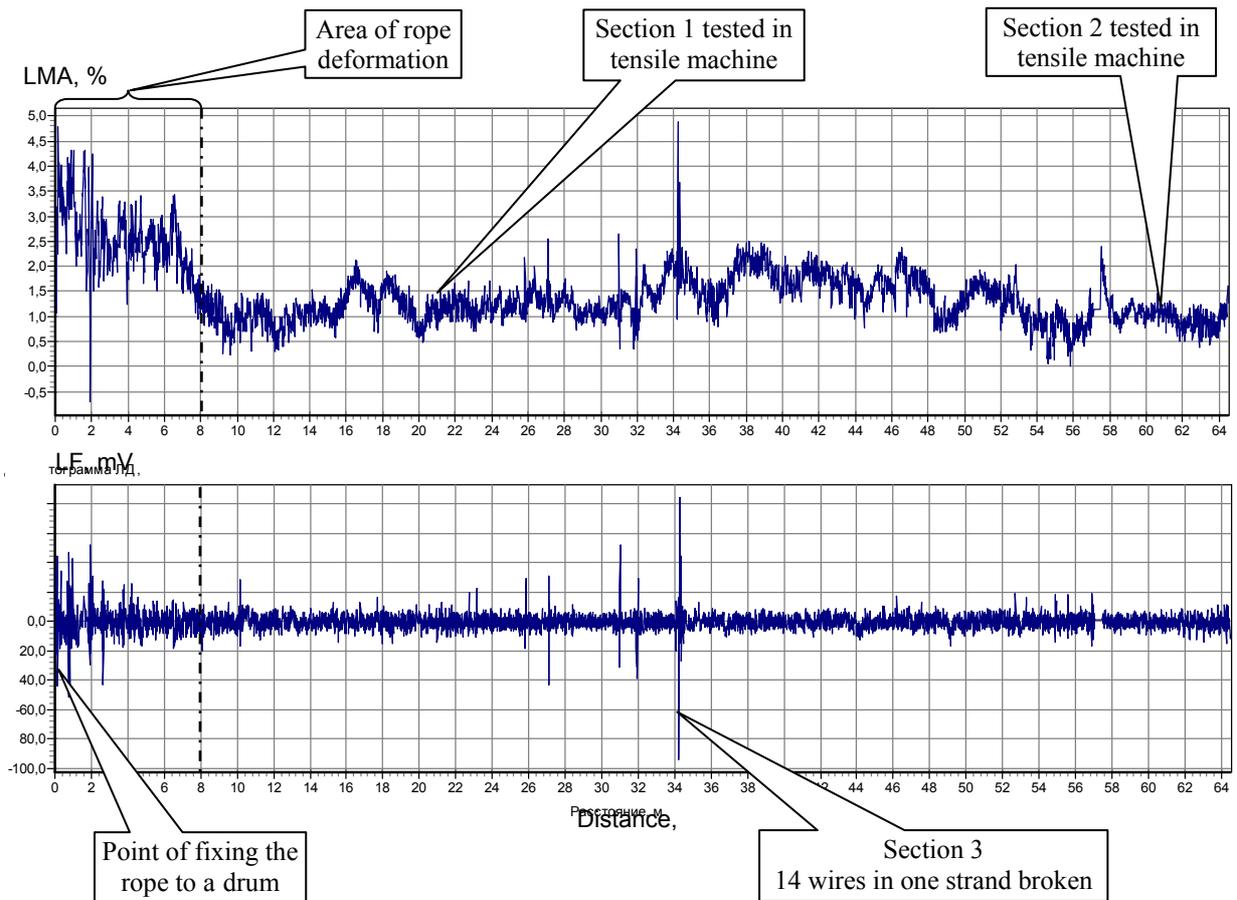
The charts covering two fragments of the broken rope 0-52 m and 58-64 m are shown in Figure 4. The LMA is not over 5%, the most worn sections being at 0-8 m and at 34 m. Broken wires and strand deformation were detected by visual inspection in the section 0-8 m. There is significant signal at 34 m distance. The signal was identified as breakage of no less than 11 wires. Breaks of one to three wires were detected at distances 26, 27, 31 and 32 m. Visual inspection of the rope section at 34 m showed 14 wires broken over a 60 mm length ( $6d$  length) (Figure 5). The appearance of the broken wire ends indicates that the breaks appeared long before

**Figure 4:** Data charts of the crawler crane DEK-251 boom rope (rope B).

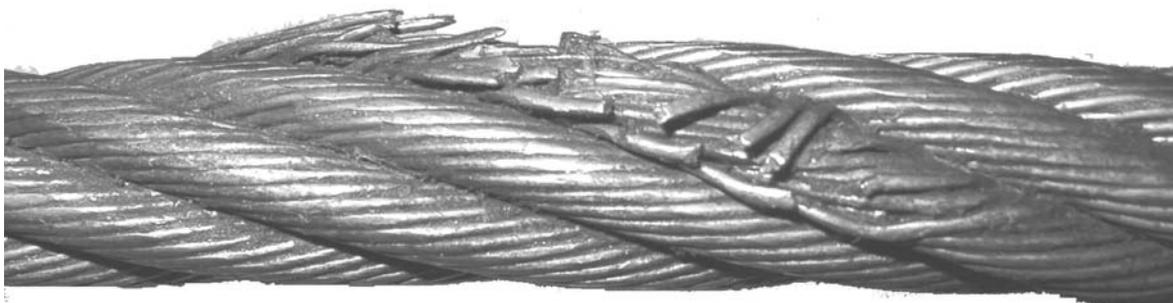
the rope failure. Taking into consideration that the rules permit not more than 14 breaks on  $6d$  length, the rope must be discarded. Furthermore, according to Sukhorukov *et al.* (2001) the breaks concentrated in one strand increase the fault hazard. However, the breaking strength of the unworn rope sections 1 and 2 (Figure 4) is only 7.5% less than nominal value. Visual investigation of the broken rope ends shows that only about 25% of wires broken at the rope failure location have needle-shaped ends indicating that they were broken by tensile stress. The ends of the remaining broken wires look typical of fatigue failure. Of course, the group of wires broken at the distance 34 m could be detected visually (Figure 5) but this does not happened while the rope in use: such as in the case mentioned above.

**Figure 5:** Wire breaks of the rope B one strand (section 3 in Figure 4).
