***Providing integrity of flare stacks at refineries
by MFL inspection of guy ropes***

***1st Oman inspection & Integrity Conference
16-17 October 2019***

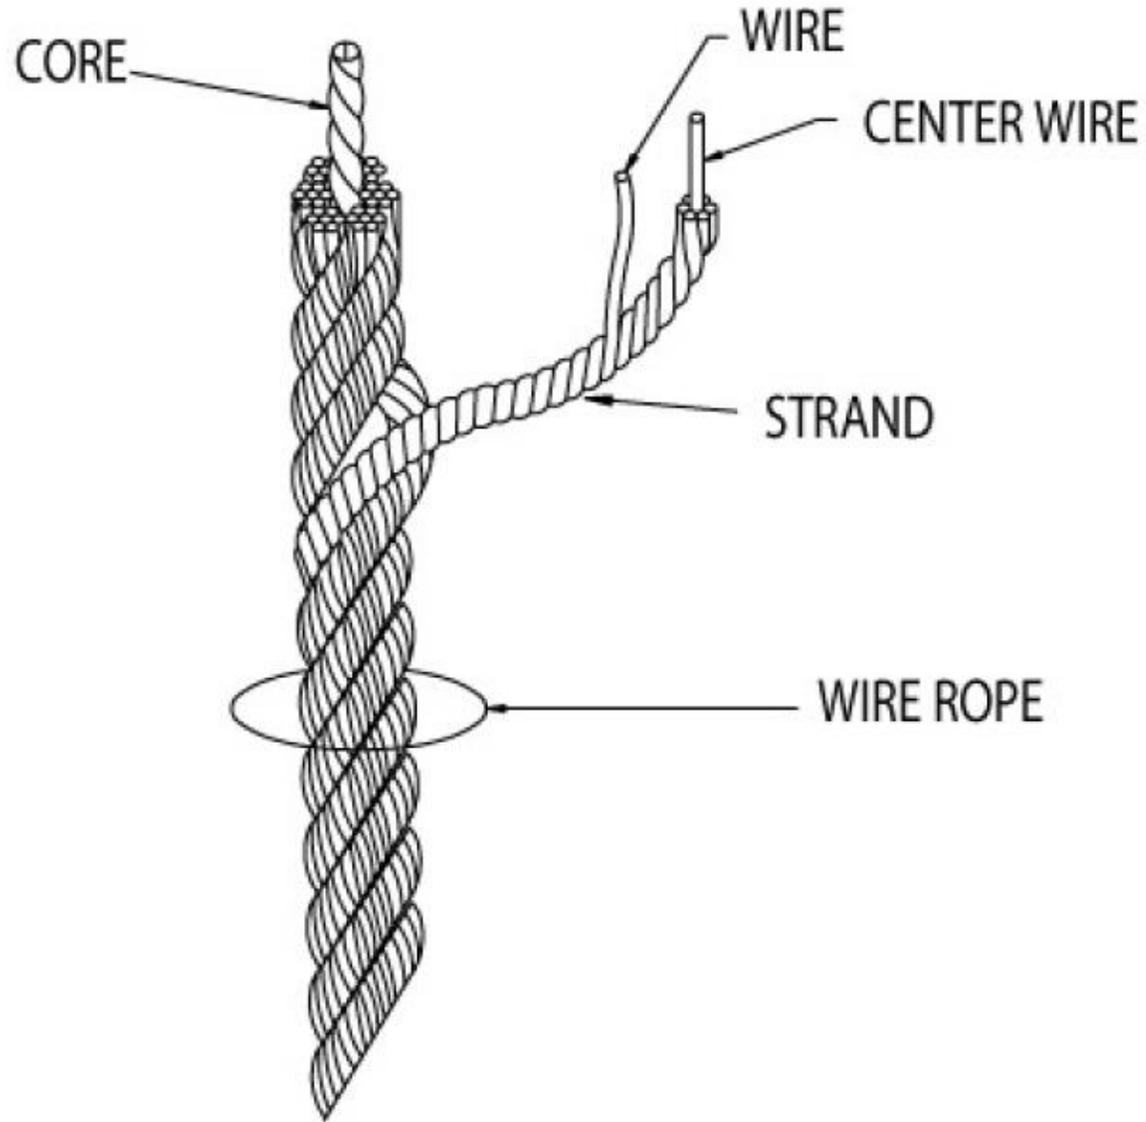
The wire rope

Ferrous steel wires

Diameters from 13 to 45 mm

Lubricated

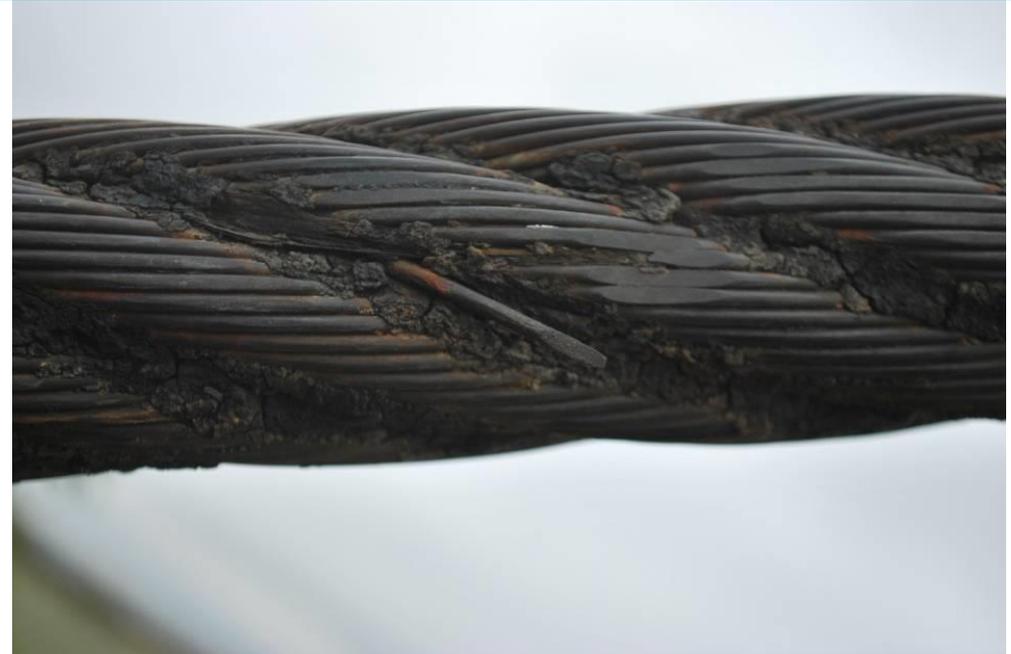
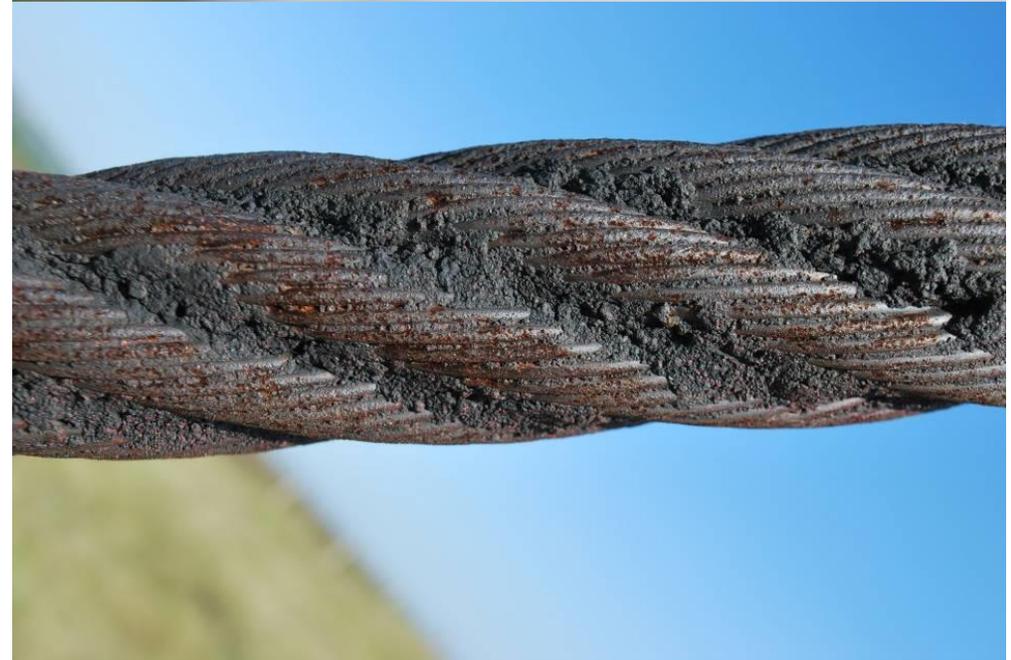
Guy rope wear

-**Axial tension** causes **stress**.

-**Wind loads** cause **vibration**
– leads to internal wire **nicking**.

-**Sand storms** cause surface **abrasion**.

-**Atmosphere precipitation** causes **corrosion**.

-**Combustion products** of flare causes **etching**.

-**Mishandling during installation** causes **kinks**.

LMA (Loss of Metallic cross-sectional Area)

& **wire breaks** (Local Faults).

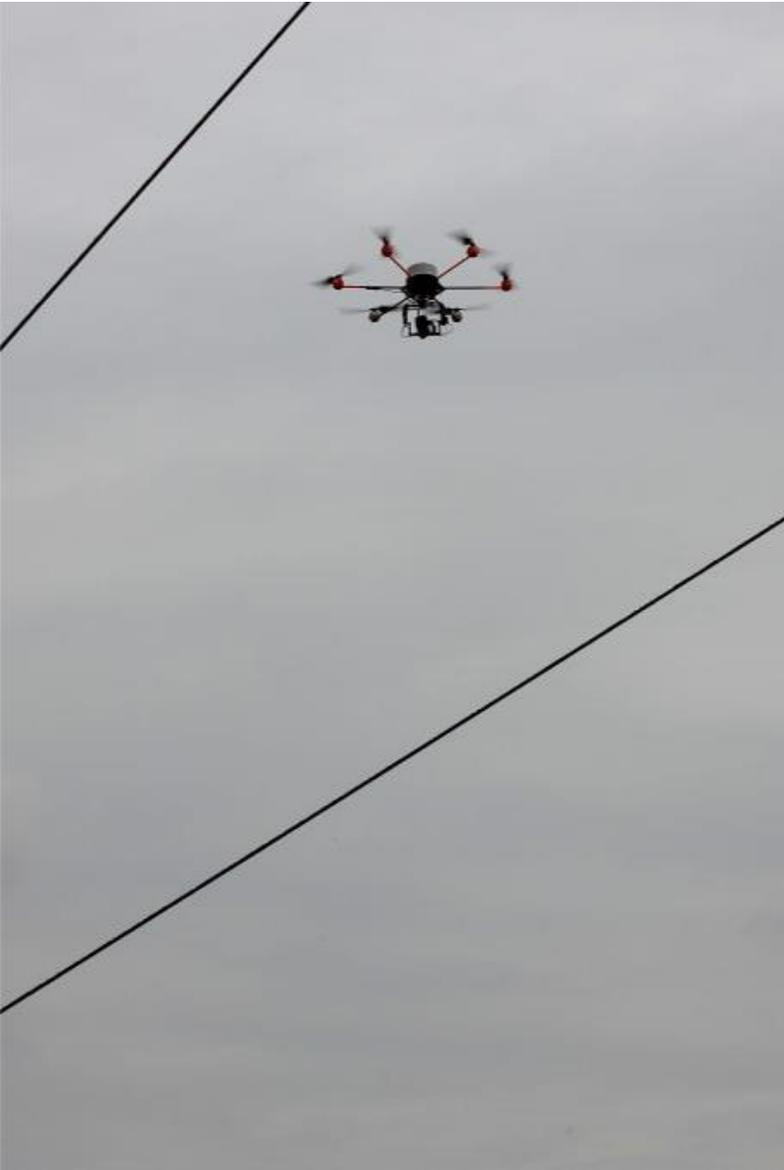
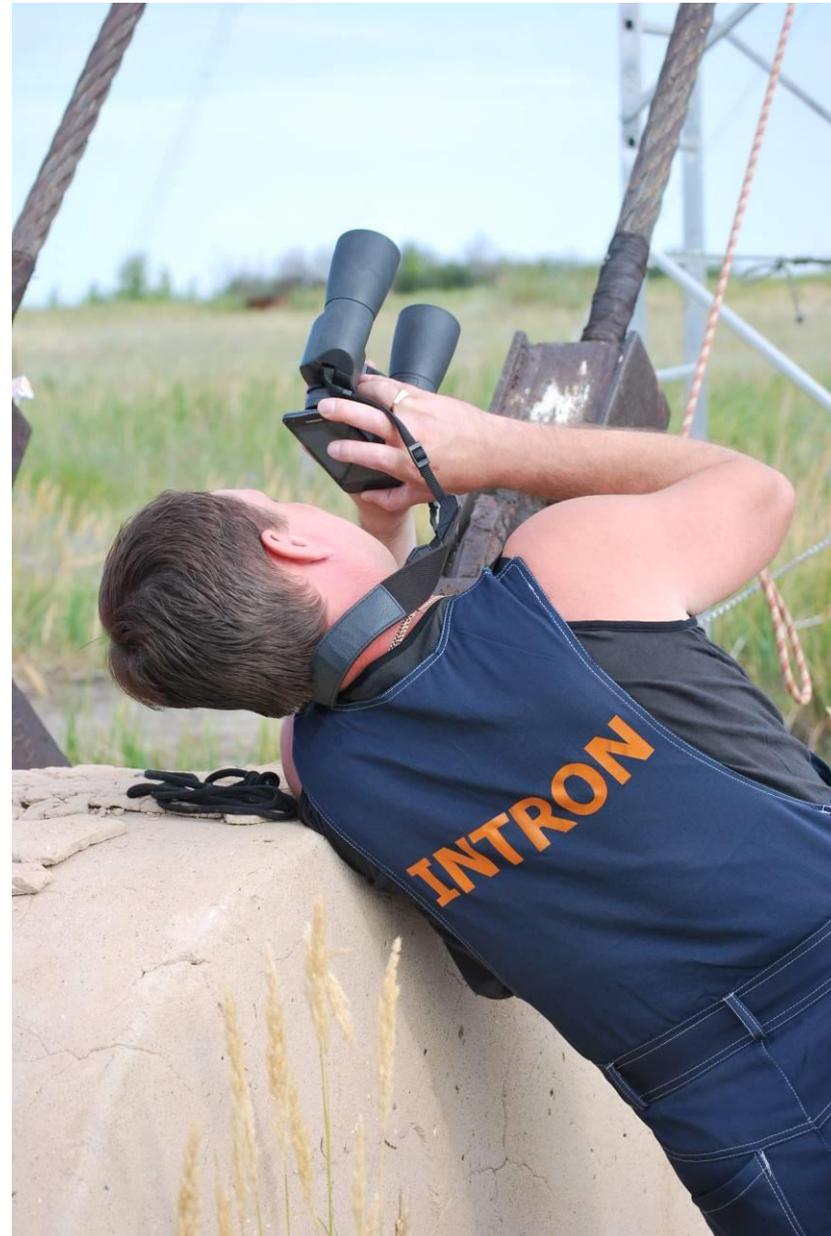
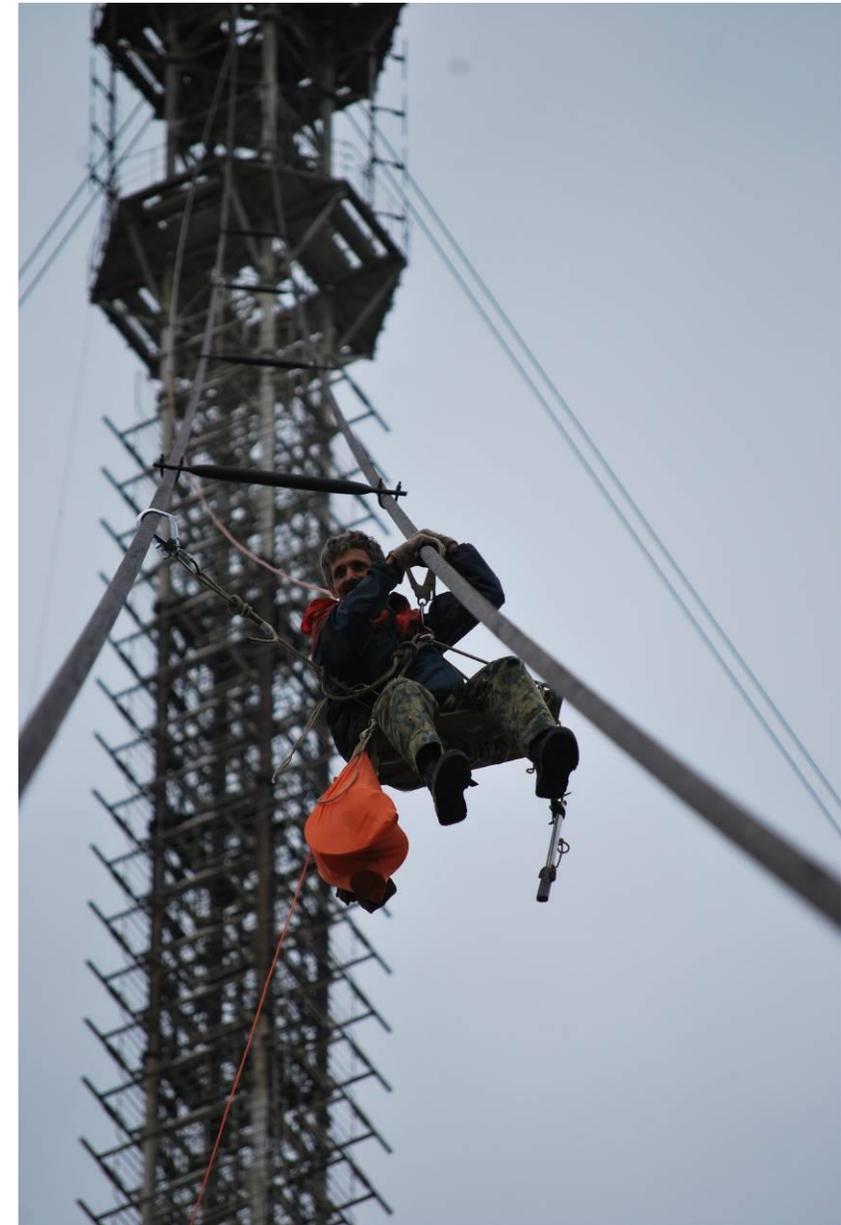
Visual inspection of guy ropes

Presence of surface lubrication, pollution and icing hinders accuracy.

Only outer wires can be inspected, internal defects unseen.

A good wire rope can be discarded due to insignificant outer wear.

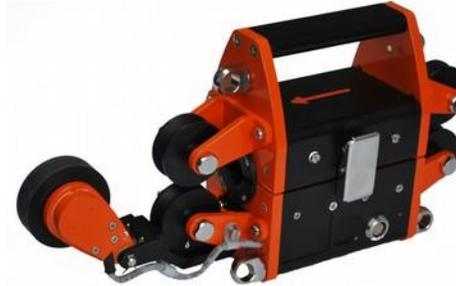
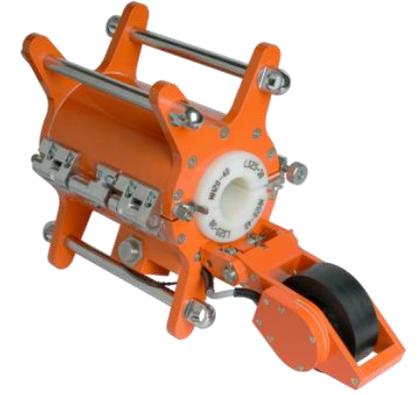
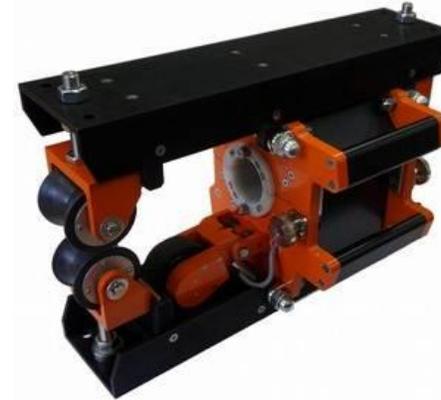
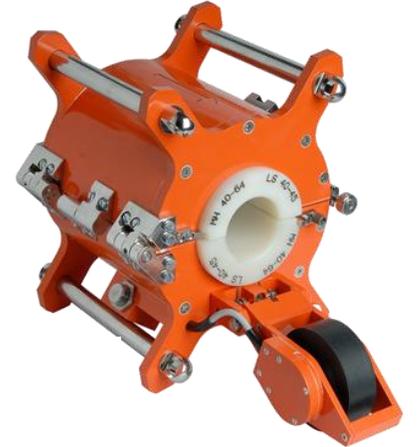
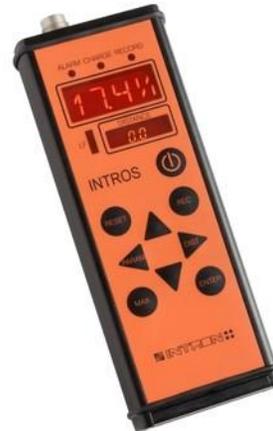
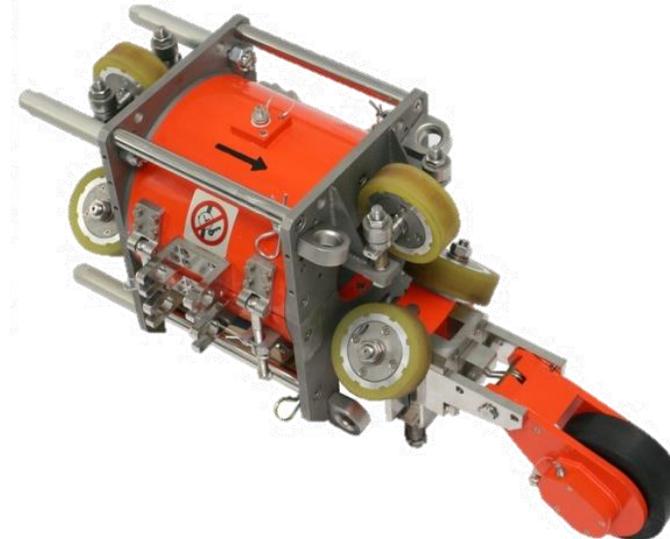
INTROS Wire rope flaw detector

Magnetic head on the rope.

Basic unit for logging data.

Wintros software.

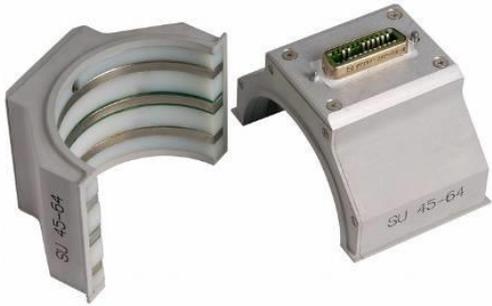
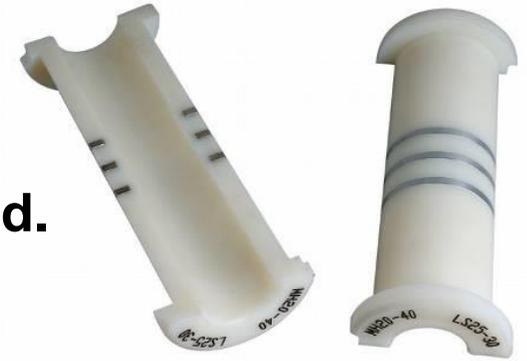
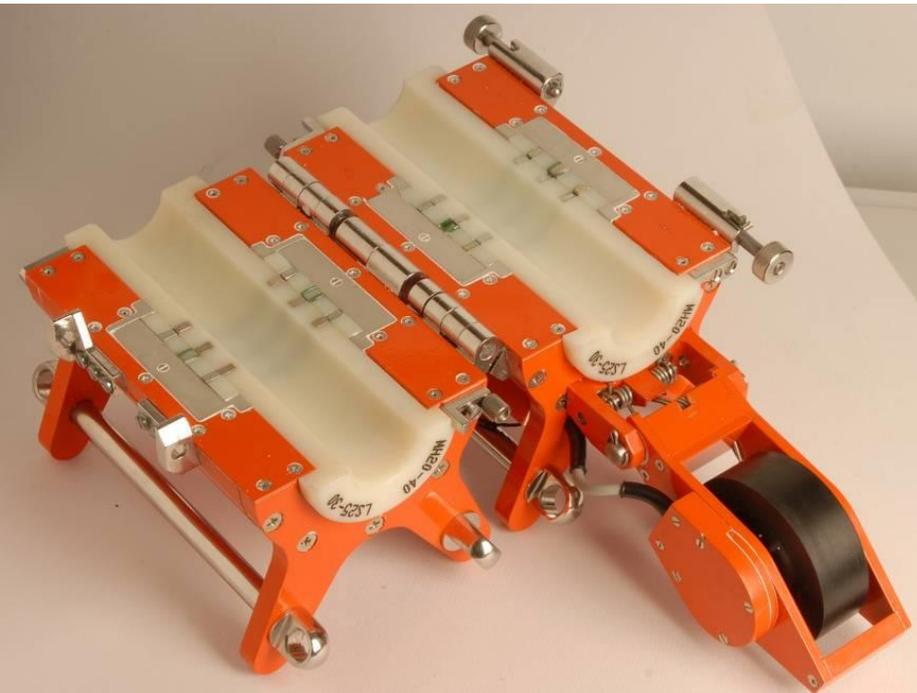
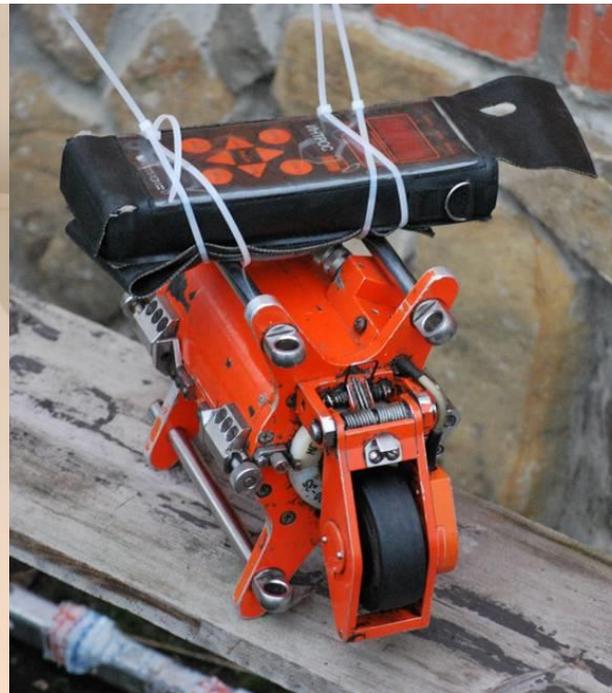
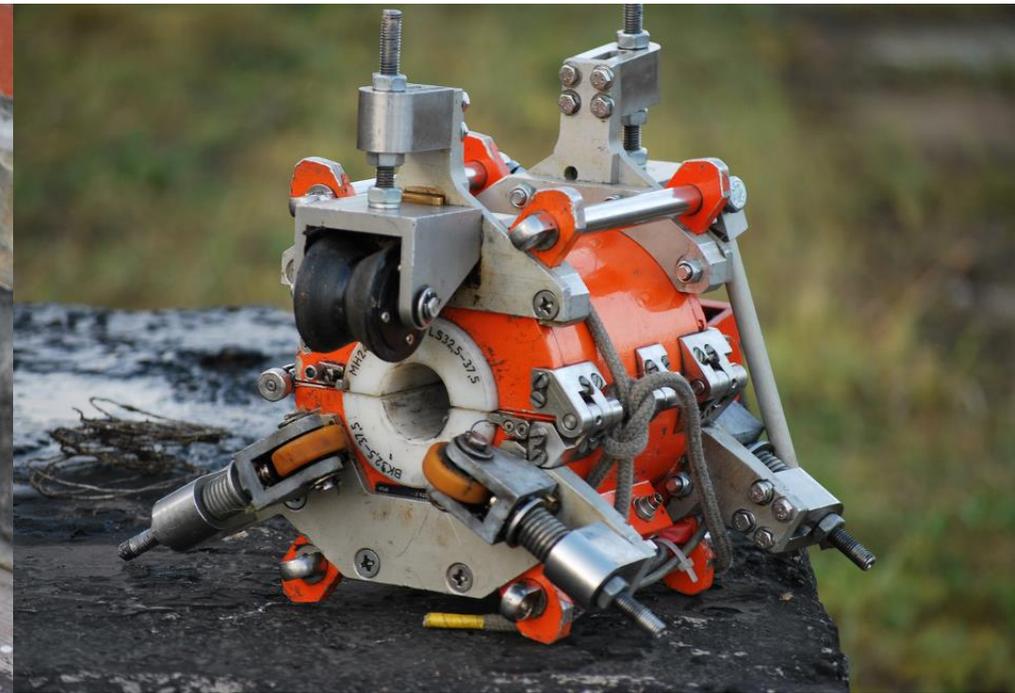
Inspection Procedure – Equipment preparation

Selection of magnetic head.

Installing corresponding sensors and sleeves.

Affixing the calibrated Basic Unit to the Magnetic Head.

Setting up roller system (optional).

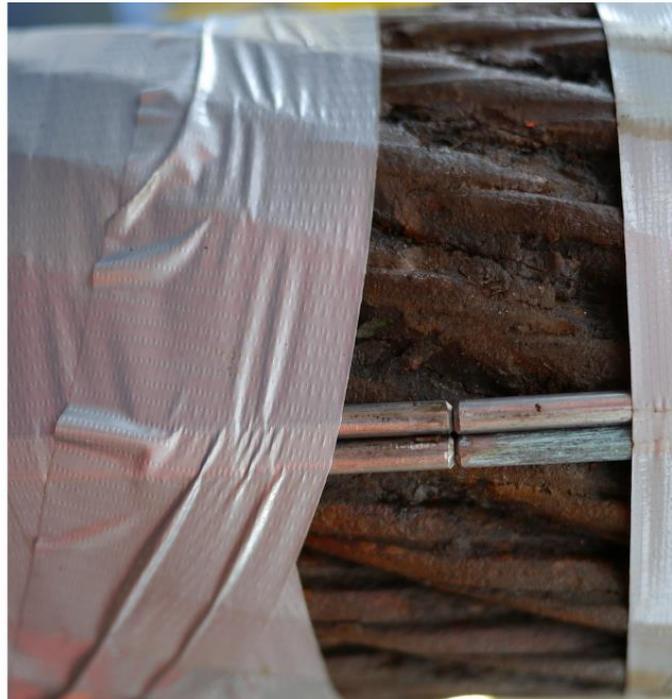
Inspection Procedure – Calibration

Requires two known LMA values:

A **whole rope (0% LMA)** and a section with **known LMA** (amount of broken wires),

A **whole rope (0% LMA)** and additional wires taped on (**negative LMA**),

A **whole rope (0% LMA)** and **no rope (100% LMA)**.

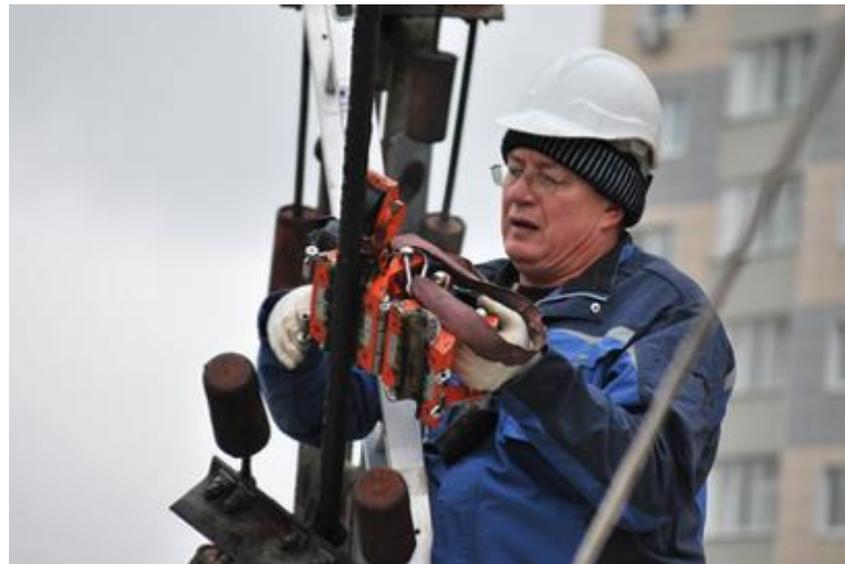
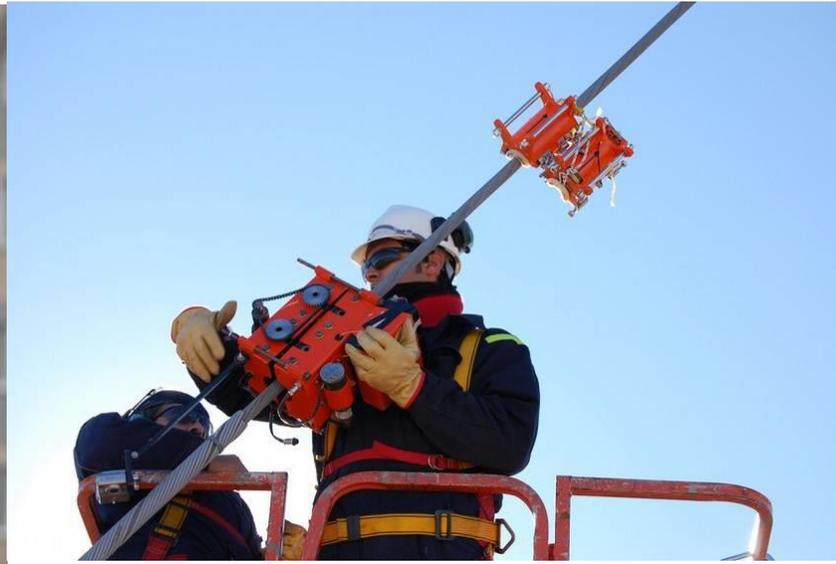
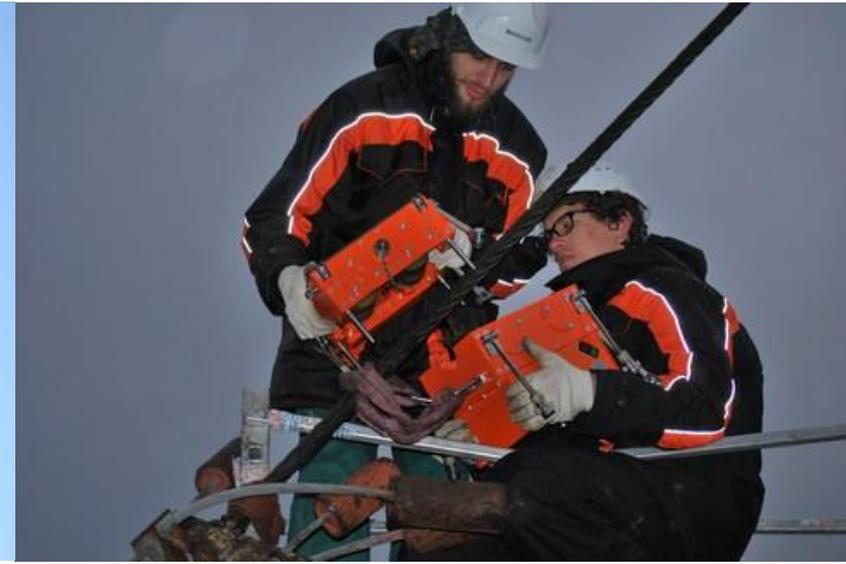
Inspection procedure - Setup

Input of zero distance point.

Installation of the INTROS on the rope.

Hoisting of belay line (return sling).

Installation of the Climber unit / Connecting winch hauling rope.

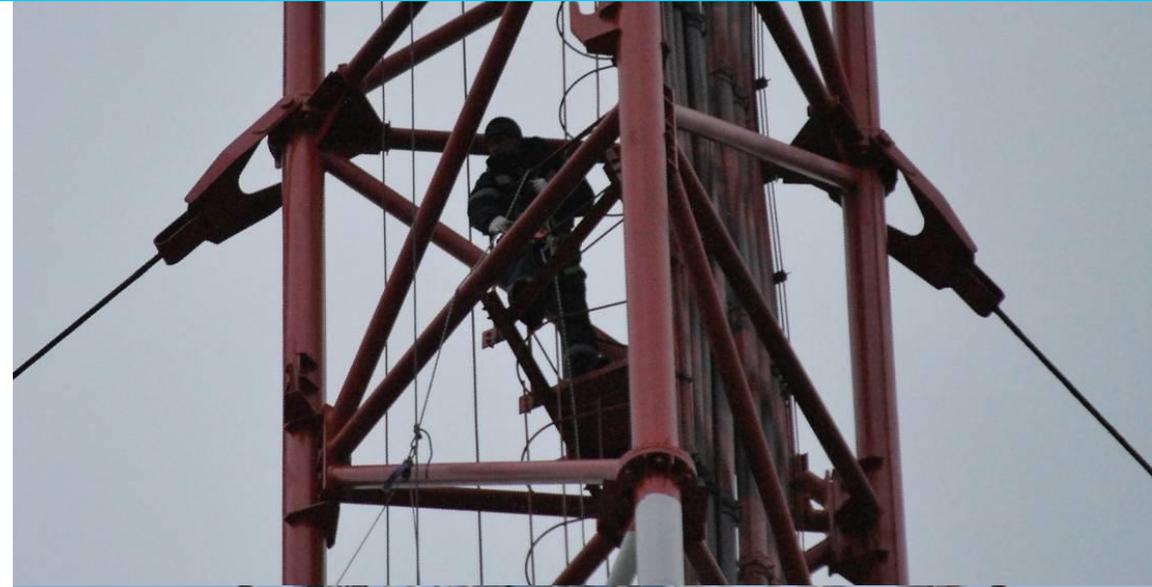
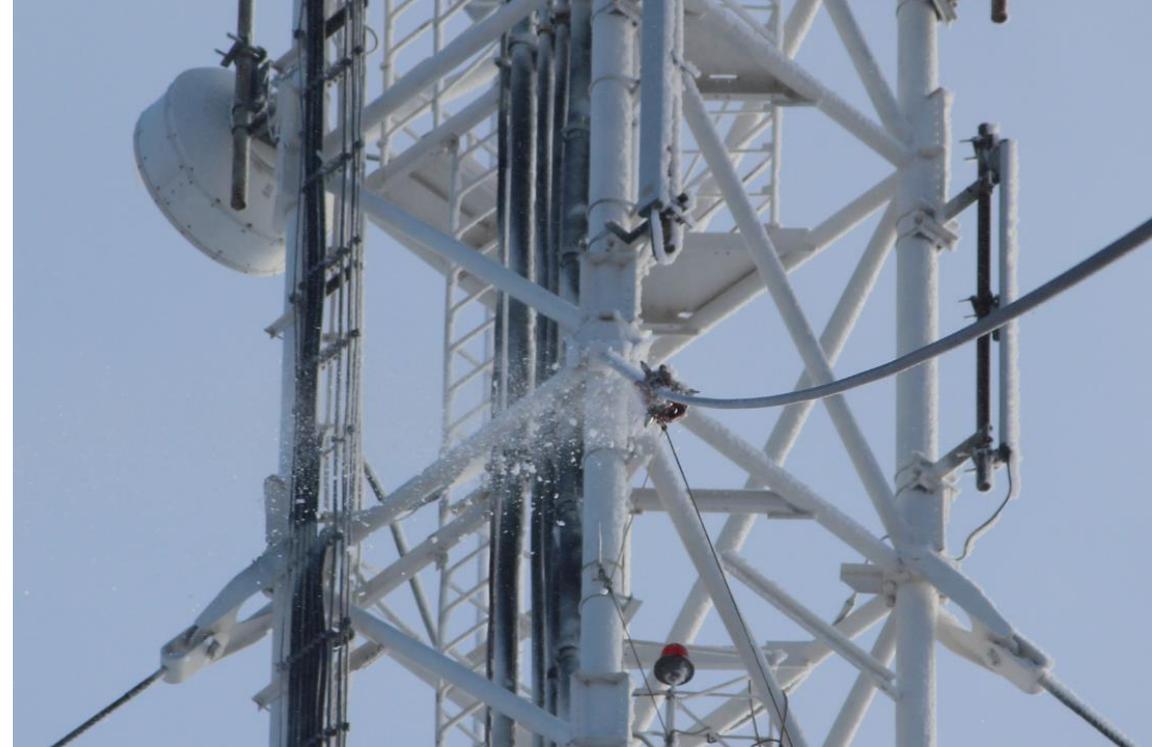
Inspection Procedure – Winch

Magnetic head to travel the whole length of the rope pushed by Climber / pulled by winch.

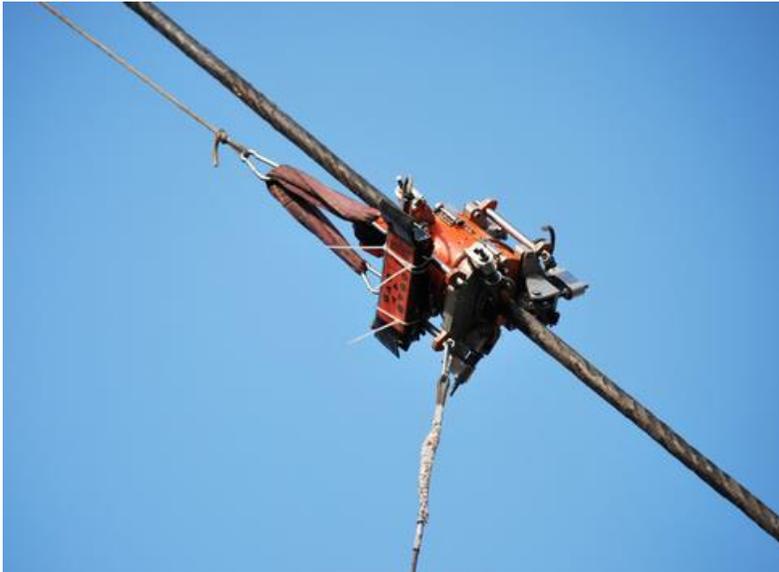
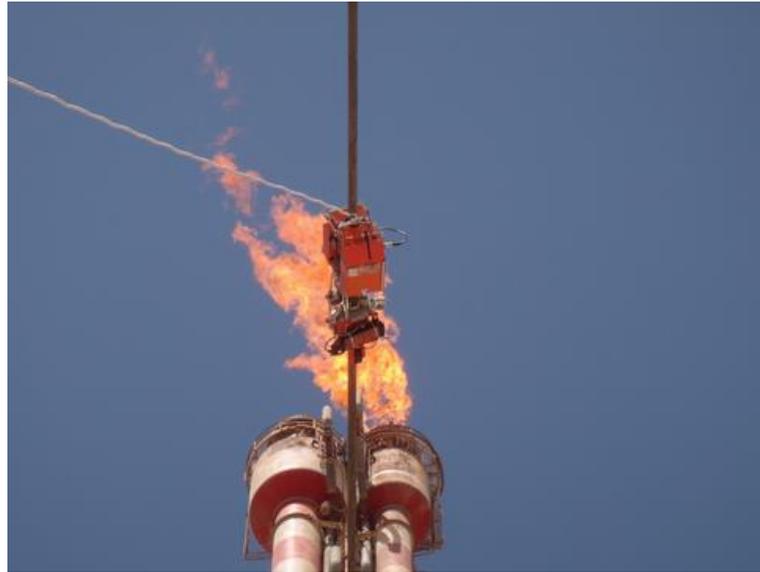
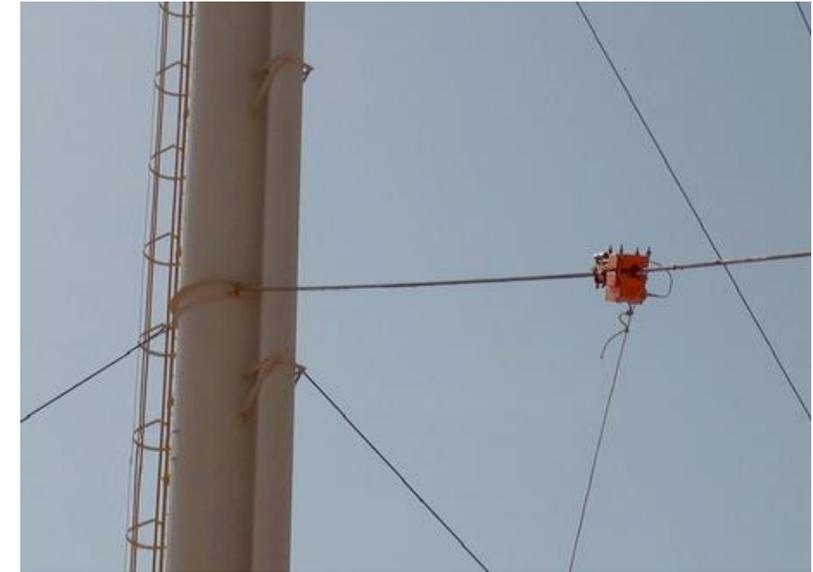
Inspection Procedure – Recording

Return sling prevents rotation and aids to pull the Magnetic head down.

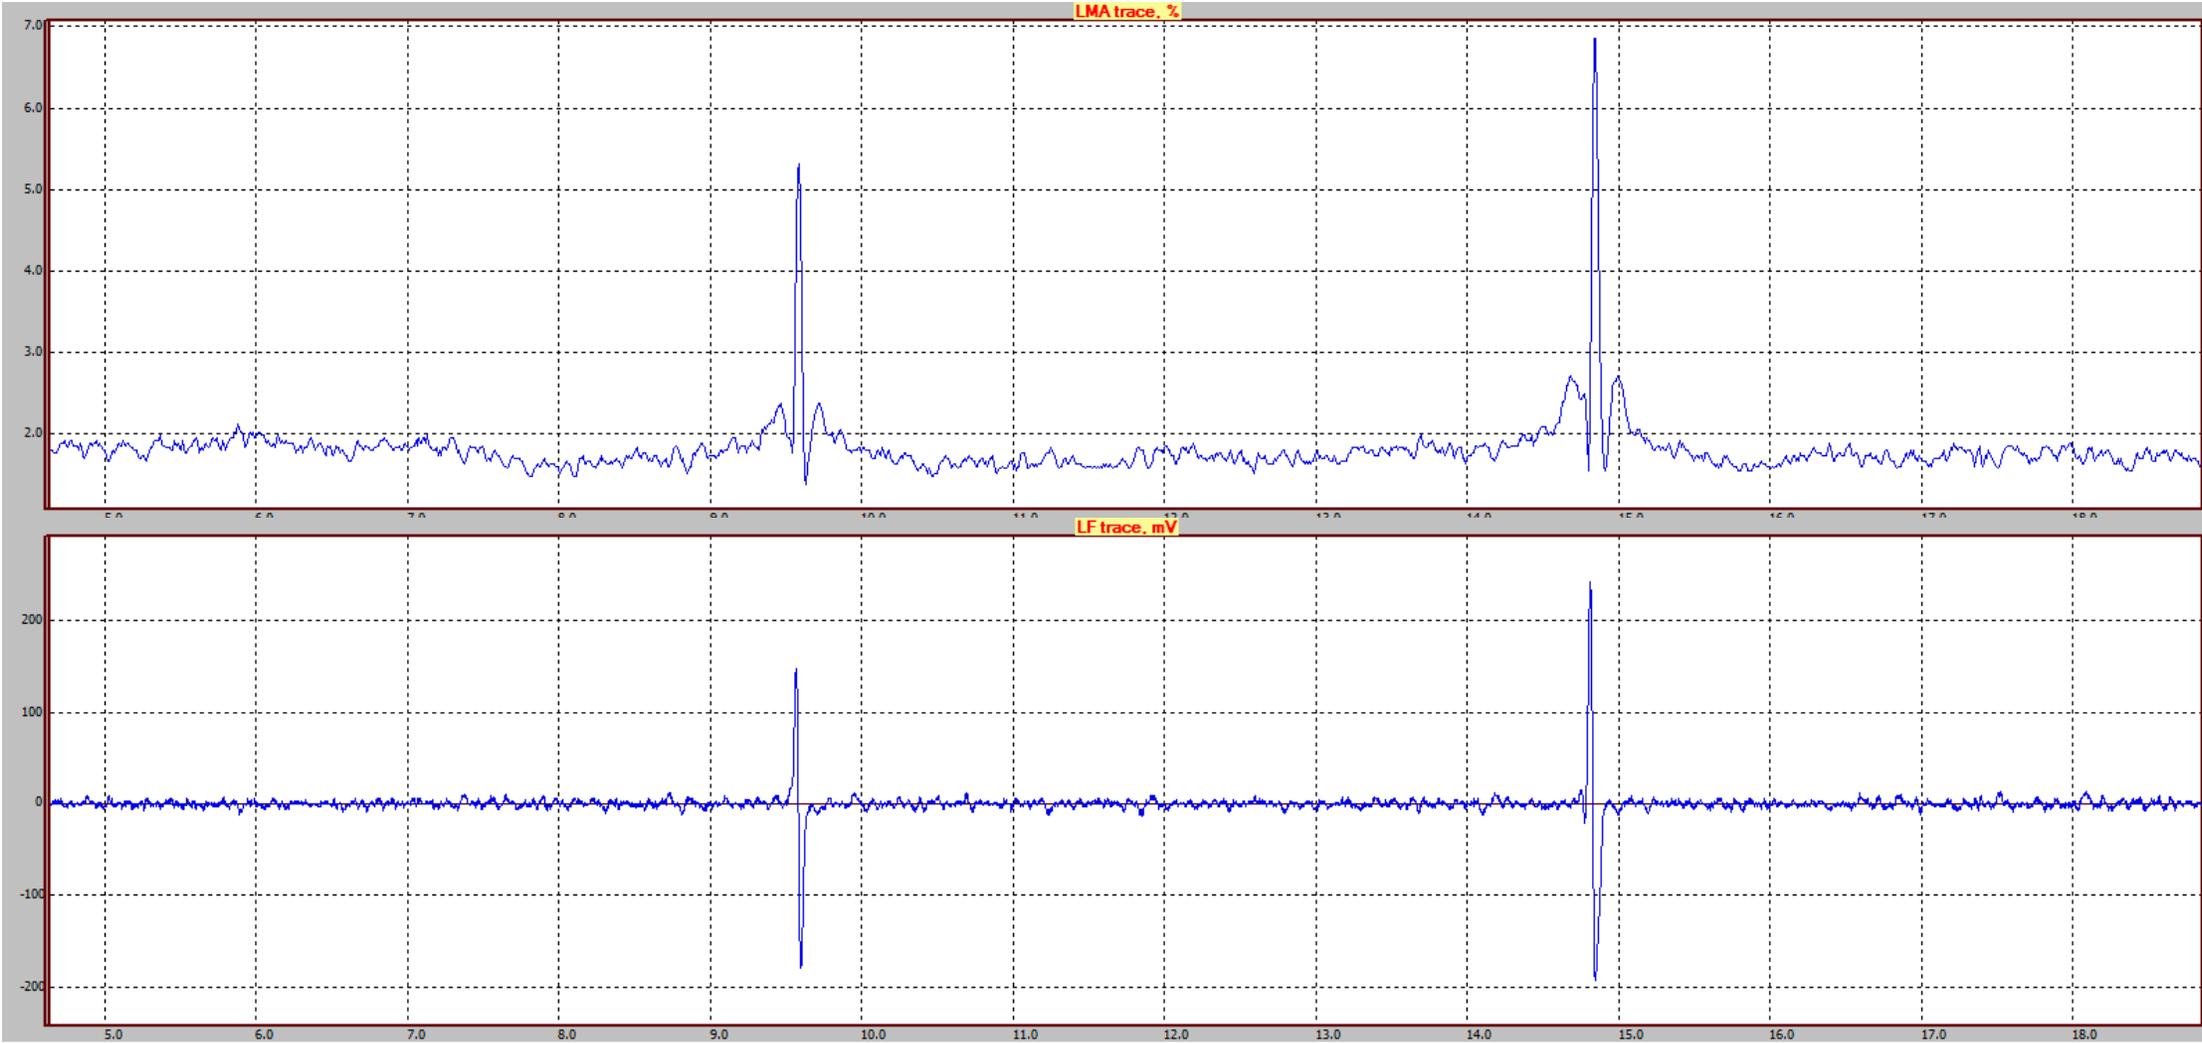
Zoom-in section of 45 mm guy rope containing defects

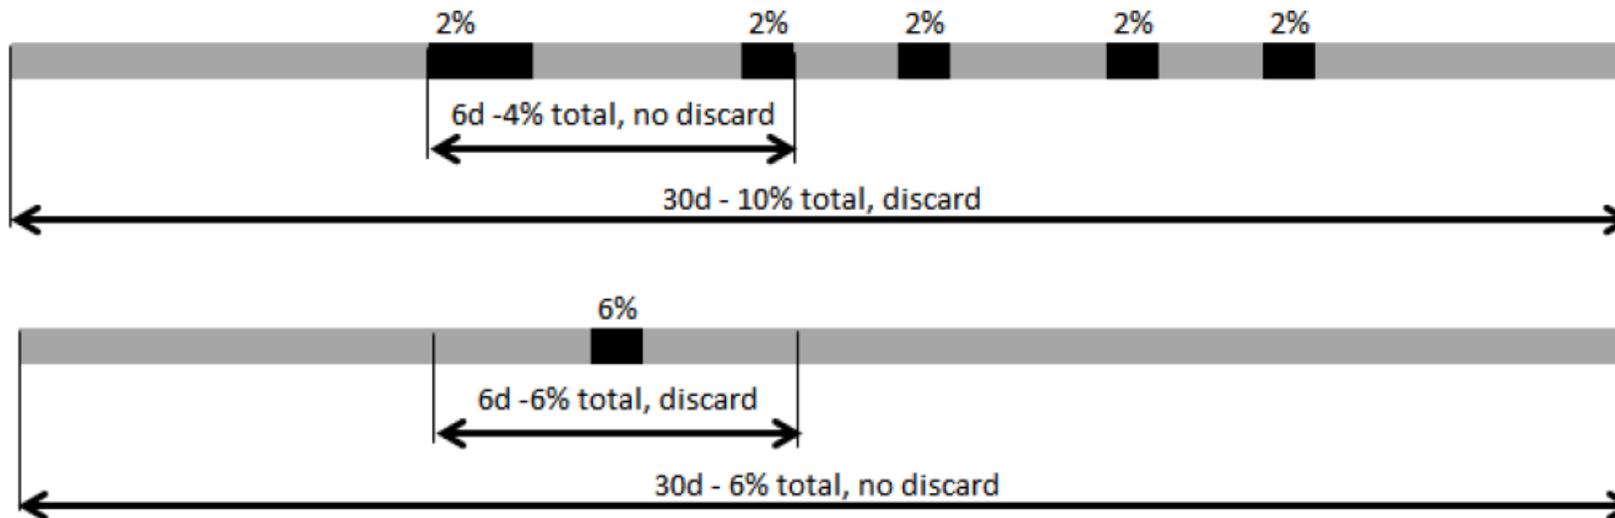
Inspection Procedure – Discard Criteria

Current standard: ISO 4309:2017

Loss of Metallic Area (expressed in %)
Over a length of $6d^a$	6
Over a length of $30d^a$	10
^a d = nominal diameter of rope.

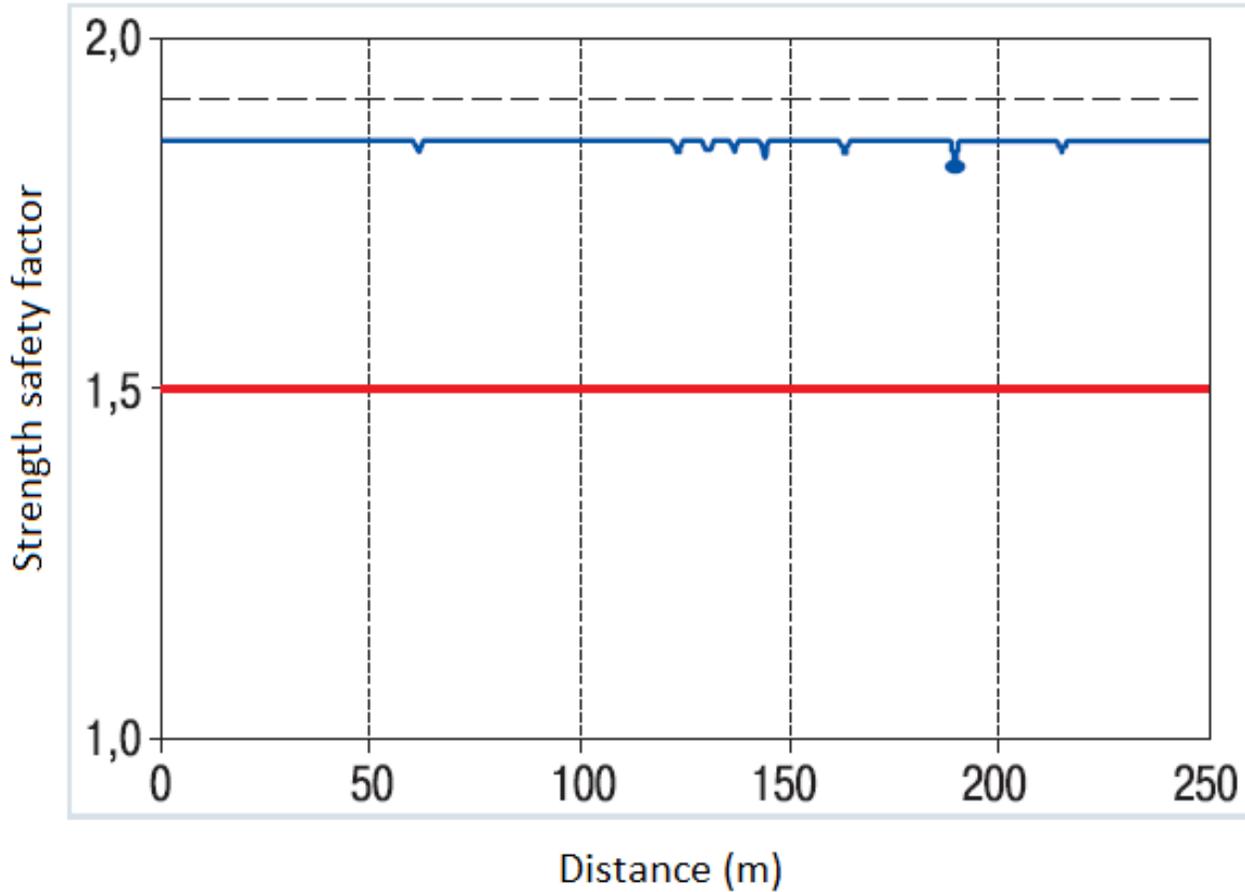
Rope Strength Safety Factor Calculation

Strength safety factor.

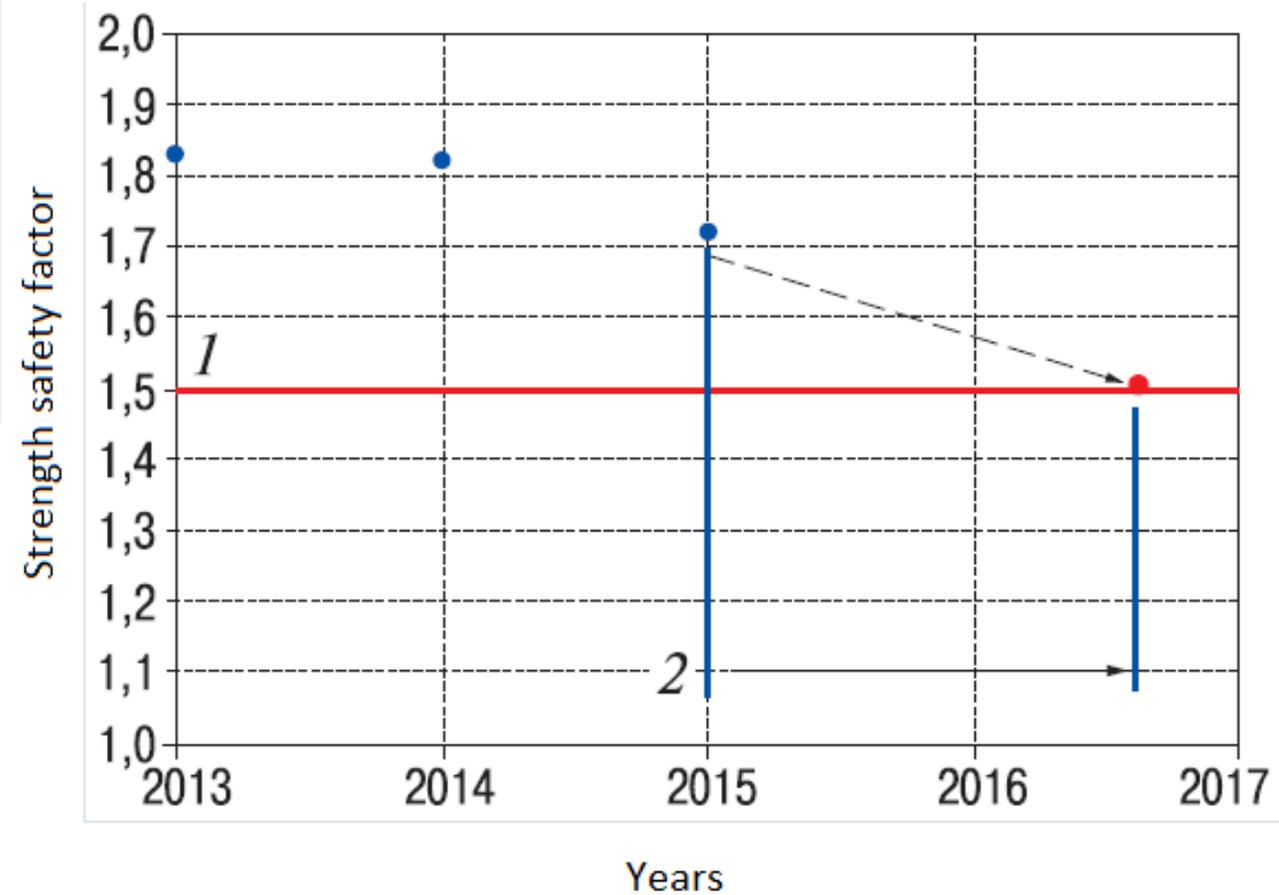
Strength safety factor regression.

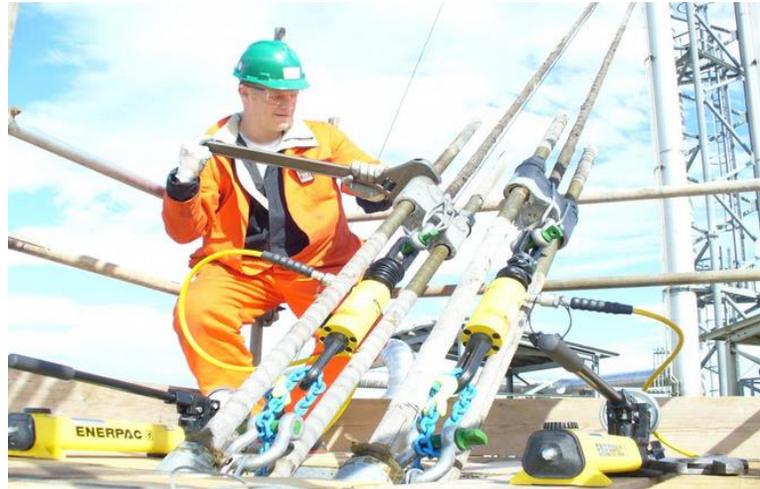
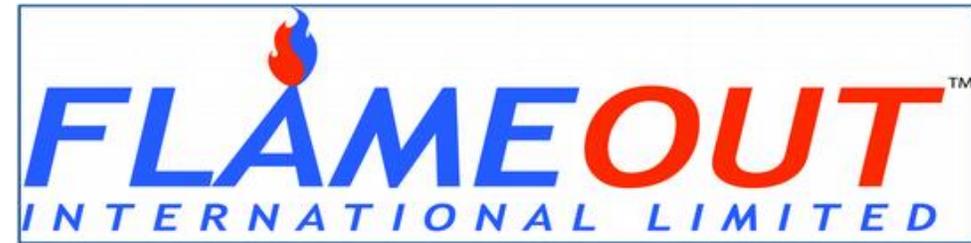
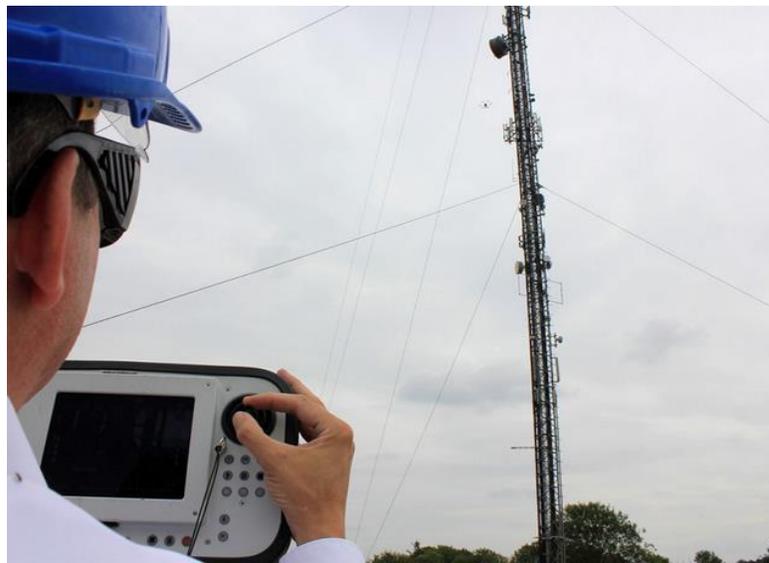
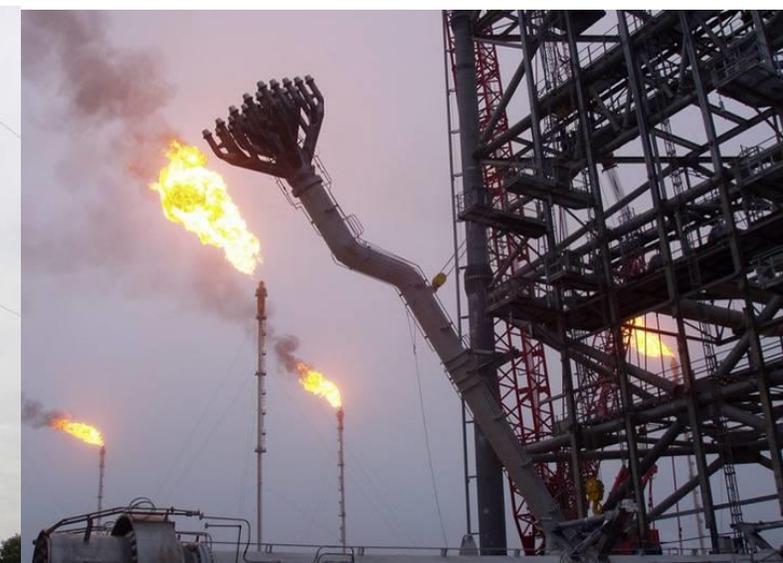
Our partner – Flameout International

Tension measurement
& re-tensioning.

Tension meters & total
stations calibrated to match
correct guy wire.

Flare tip, deadman anchor
and guy wire replacement
also available.
